**APPENDIX 1**

**News Report by Parikiaki**

The following text and photographs are taken from the website of a newspaper serving the Greek and Cypriot communities – see <https://www.parikiaki.com/2023/06/fire-at-terraced-houses-north-finchley/> . The text is identical to that on the London Fire Brigade website (<https://www.london-fire.gov.uk/incidents/2023/june/fire-at-terraced-houses-north-finchley/>) but I have changed the order in which the photographs are shown and have added captions to them.

# **London Fire Brigade: Summary Investigation Report**

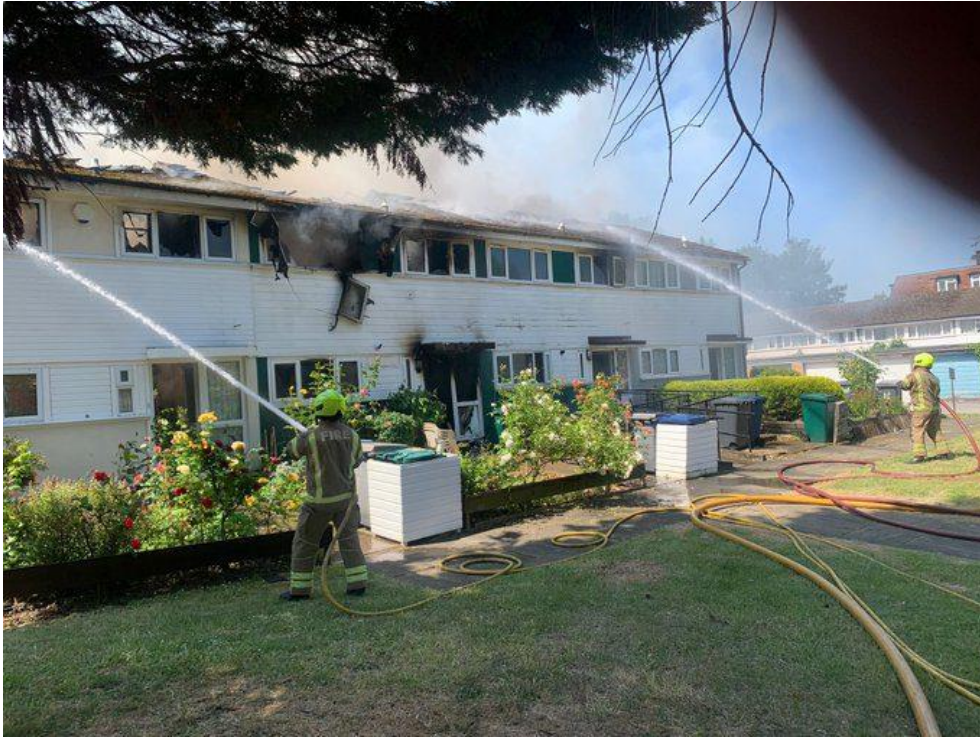
The front of the houses. No 9 is on the left. No 15, the least damaged, is at the right-hand end of the terrace. Note that there has been no fire-spread across the uPVC cladding visible at the front of the terrace, despite severe fire conditions within the centre two houses seen in this view.

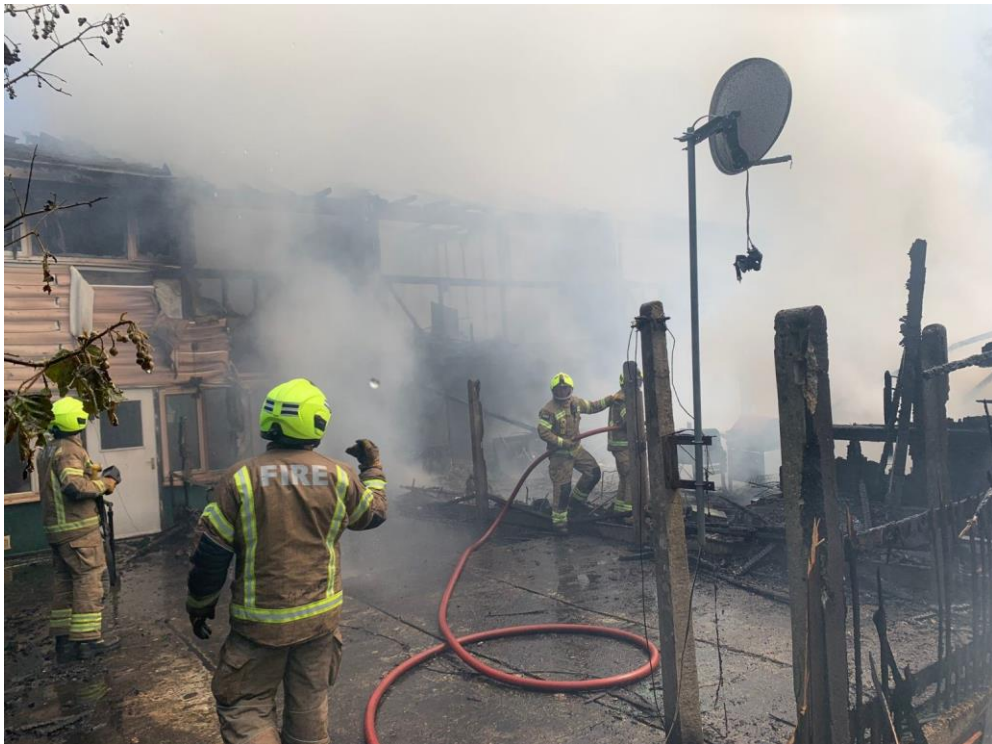
The rear of the terrace, showing the yard at the rear of no 13. Most of the smoke and steam is coming from the yard at the rear of no 11.

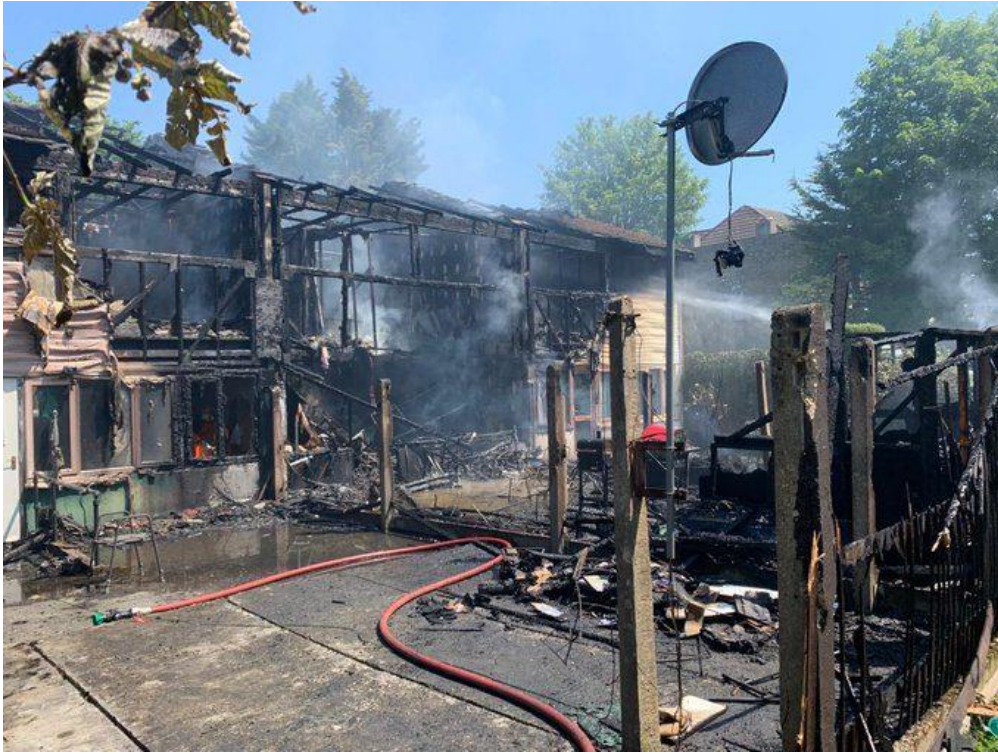
A later photograph of the yard at the rear of no 13. The timber fence at the rear of this yard has been destroyed. The section that would have been directly in front of the camera was probably torn down by firemen for access but that to the right has burned. The timber panel fence between the yards of 13 and 11 has been consumed by fire, as has the fence between 11 and 9. It appears from the debris that there were a large number of items in the yard of no 11, including a shed at the rear. All these items have been consumed by fire, as have some items in the yard of no 13.

The pattern of damage to the uPVC cladding corresponds to what I would expect from flame impingement from a severe fire burning close to the building and involving the whole width of the no 11 yard, plus the fences on either side. The flame impingement seemingly extended beyond the lines of the party walls, destroying areas of cladding on both no 13 and no 9.

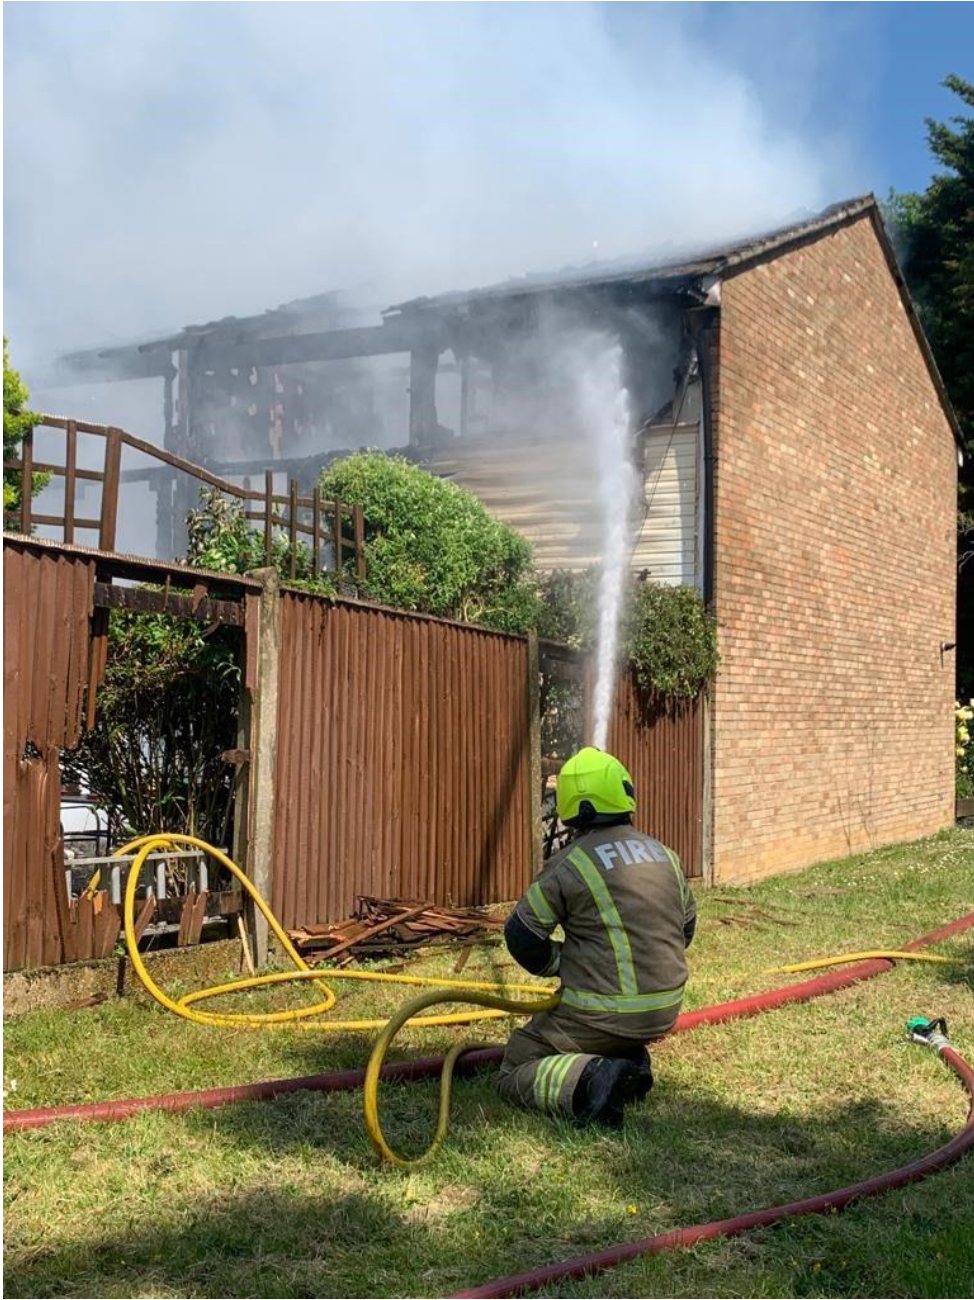
A fireman is directing water into the rear of no 9.

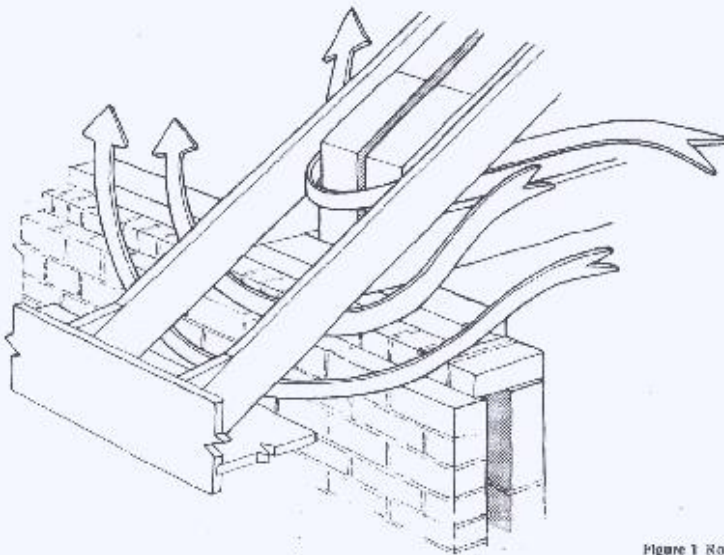
Figure 1 Routes for spread of fire at eaves

**Pitched roofs: boxed eaves — preventing fire spread between dwellings****FAILURE:** Spread of fire, within boxed eaves, between adjoining dwellings.**DEFECTS:** No cavity barrier to close voids in boxed eaves at separating walls; incomplete separating walls.

In a BRE Survey of house design and construction, there was found to be a potential route for fire between adjoining dwellings at every continuous 'boxed eaves' detail. Most also had other routes for fire past the end of separating wall (Figure 1) and some of these routes were wider than they might otherwise have been as a result of incomplete blockwork which had been concealed by the adjacent rafters from subsequent inspection. Fires are known to have spread between dwellings through these routes.

is clear that designers and builders are generally unaware of their significance. The Building Regulations 1976, E8 (1) require a separating wall to be imperforate and to form a complete vertical separation between dwellings, including their roof spaces. There will be routes by which fire can spread between dwellings if the separating wall stops at the inner edge of the wall plate and if the voids within the boxed eaves are not closed. These defects are significant in all cases, and particularly so where there are habitable rooms in either roof space.

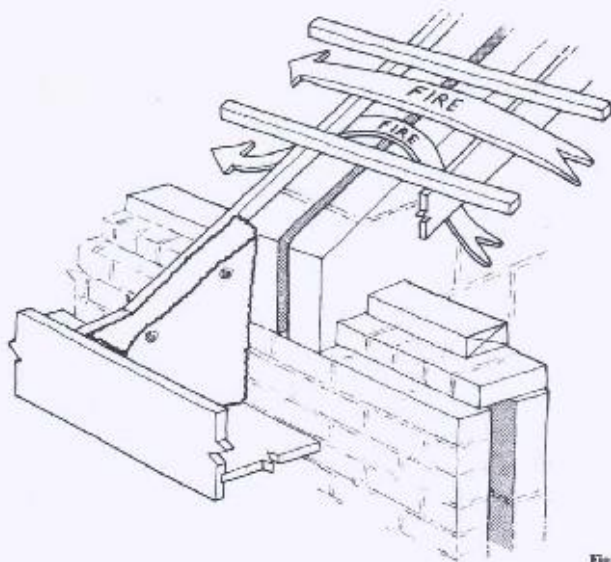
Figure 1 Routes for spread of fire over separating wall

**FAILURE:** Spread of fire over top of separating wall between adjoining dwellings.

**DEFECT:** Inadequate fire-stopping between the top of the separating wall and the underside of the roof covering.

A BRE survey of house design and construction revealed that fire-stopping at the top of separating walls is rarely effectively done. For adjacent small residential buildings, neither of which exceeds 12.5 m in height, the separating wall need not be carried up above the roof covering provided that the covering to the roof is non-combustible and the junction between the separating wall and the roof covering is fire-stopped. If the gap is *not* properly fire-stopped, fire can spread from one dwelling to the next.
