Fire Spread Investigation Report

**9-15 Moss Hall Grove
London
N12 8PE**

For
Barnet Homes
2 Bristol Avenue
London
NW9 4EW

11th July 2023

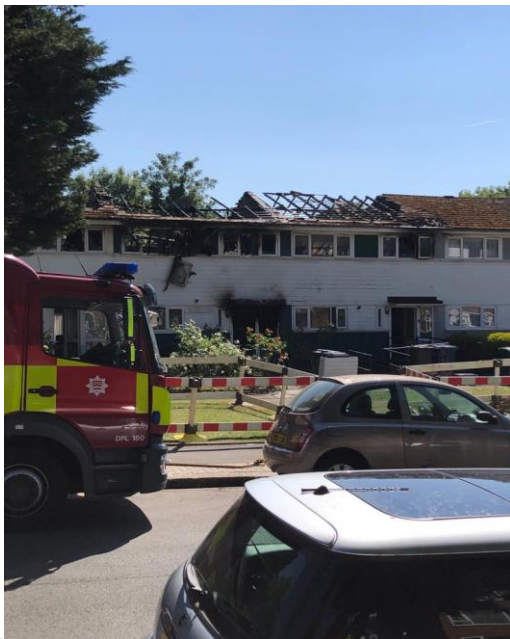
1.

Front

3.6.1 It is evident from the UPVC and timber sheet cladding arrangement that can be seen in photo's 1 & 3 that it bridges the vertical compartment line of the party wall between the individual terrace houses. This bridging of the compartment line by combustible materials creates a route for the spread of flame and fire across the compartment line between properties at the front and rear external walls. This arrangement would not

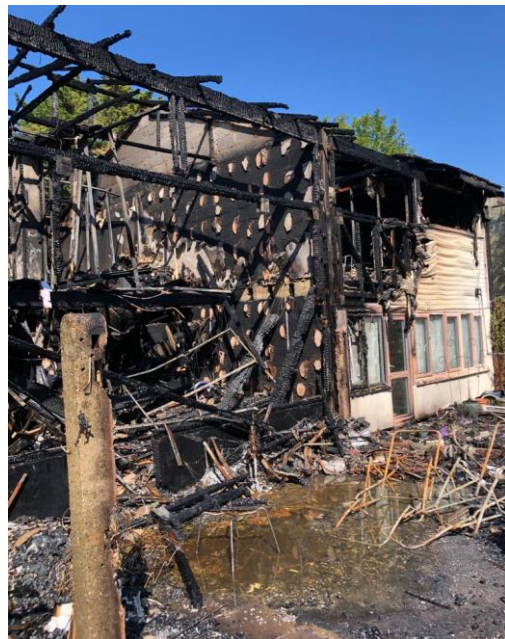
2.

Rear

1.4 It is understood that the fire originated and took hold at the rear of No.11 and rapidly spread to the adjacent buildings either side (No.s 9 & 13), resulting in severe damage to all 3 of the mainly affected properties, with No.15 having some slight damage. As a result of the severity of the damage Barnet Borough Building Control Department have made a recommendation for all fire damaged buildings to be demolished.

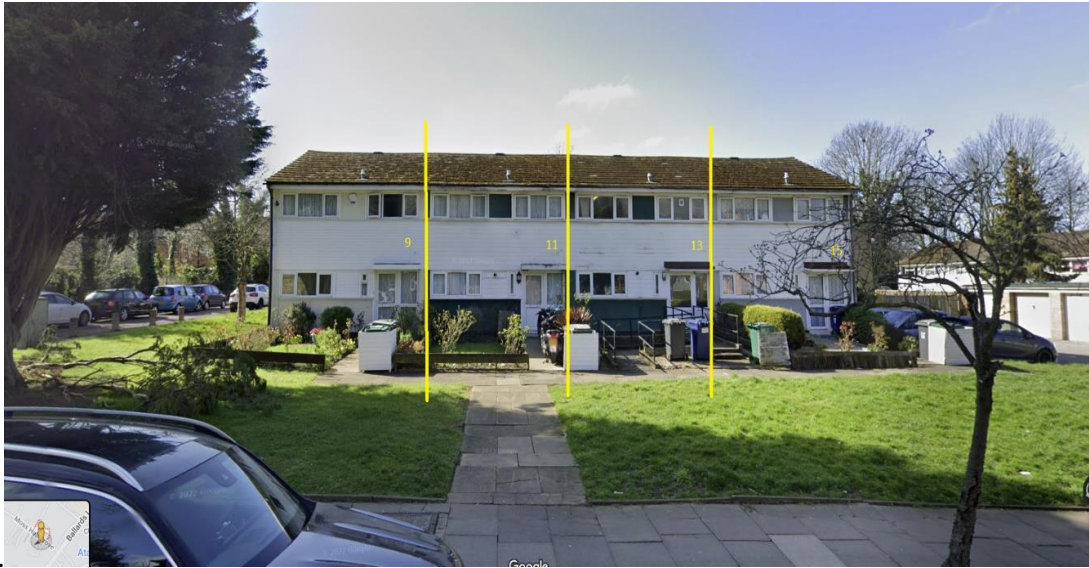
3.

9-15 Moss Hall Grove – Location of vertical compartment party walls

comply with the functional requirements B3 & B4 and presents a significant risk as evident in this case.

3.6.2 We would therefore conclude that the combustible UPVC & timber sheet cladding fixed directly to the timber battens, acted as a conduit for the spread of the fire from one compartment dwelling to another, laterally across the vertical compartment lines and did not provide sufficient fire resisting encasement to the lightweight timber structural framing.

- a) Remove all combustible cladding materials from the external wall surfaces, soffit's and fascia's and replace with non-combustible alternatives e.g. fibre cement sheathing & cladding sheets / boards which achieve Euroclass A2, s1-d0 as a minimum and fire tested under the EN 13501-1:2002 suite of fire tests for CE compliance, in order to provide resistance to external fire spread and sufficient fire resisting encasement to the lightweight timber structure.

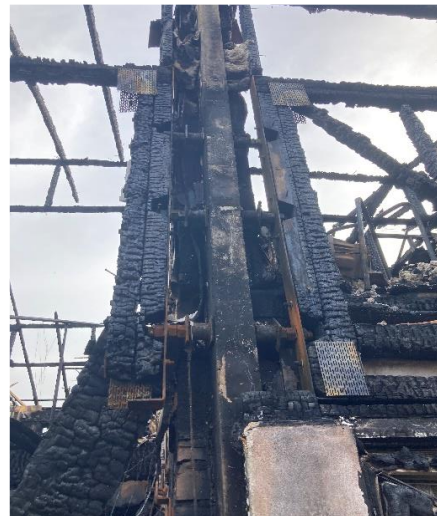
5.

2.1.2 The houses are of timber frame construction, with 260mm masonry compartment party walls separating the individual dwellings, with cavity masonry flank walls at each end of the terrace. The first floors of the houses are of timber joist construction which is in-built into the separating party walls at either end (photo 4). The front and rear walls are constructed of a timber framed arrangement which are tied to the party walls via a concrete post with mechanical fixings (photo 5). The roofs are timber truss framed, pitched roofs with a concrete tile covering.

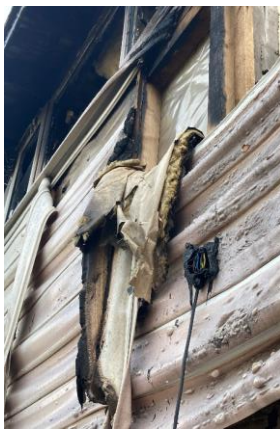
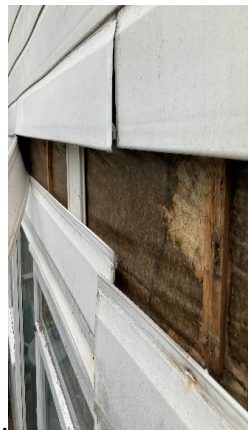
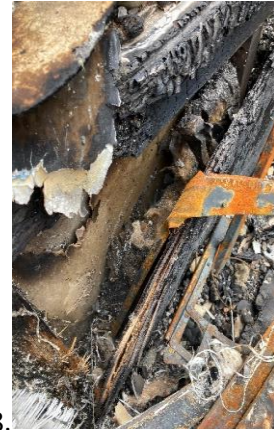
Wall build-ups for UPVC and timber sheet cladding

- 2.1.3 At the front and rear elevations the external wall finish is a mixture of UPVC shiplap cladding and a plywood sheet cladding with an exterior fabric & paint finish (photo 6, 7 & 8) which have been fixed directly to the timber framing structure via timber battens of 35x20mm, there is a slight variance to the extent of the two types of cladding finish between the front and rear elevations. It appears that the UPVC cladding was introduced as a replacement product at some point in the buildings history, most likely at the same point as when the windows were replaced with UPVC double glazing.

- 2.1.6 The timber framed walls are generally constructed of 80x35mm studwork vertical & horizontal members, spaced at regular intervals. Within the timber framework panel sections there is existing mineral wool insulation at 25mm thickness, sandwiched between two sheets of building paper within a 100mm cavity (80mm studwork frame + 20mm fixing batten). The internal lining is made up of a single layer of plasterboard with a vapour-check membrane between the plasterboard lining and the timber frame (photo's 6, 7 & 8).

3.3.1 The only elements which could be considered as potential cavity barriers are the smaller dimension timber vertical battens (35x20mm) fixed to the outer face of the timber structural frame to which the UPVC cladding is then fixed, however this detail is redundant as the combustibility and location of the cladding material allows the fire barrier to be bridged in the event the cladding material does catch fire. To meet the requirement of a cavity barrier a timber batten must be at least 38mm thick, also for a timber batten cavity barrier to be effective it must be fitted tightly between layers of non-combustible material, which is not the arrangement in this case (photo 7). Therefore, this arrangement would not comply with the functional requirement B3

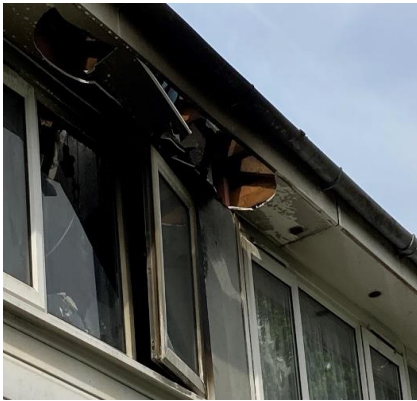
9.

4.1 Upon inspection of the damaged and exposed eaves it was clear that the soffit and fascia boards to the eaves detail were of combustible UPVC material. The eaves were vented and regular intervals via circular cut-outs to the soffit boards (photo 9)

4.1.1 The ventilation cut-outs will have provided an unobstructed pathway for flames and fire to enter the roof eaves, although this is likely to have occurred in any event due to the presence of combustible UPVC soffit and fascia boards.

- 4.2.1 It is evident from photo's 9 & 10 that there is no vertical compartmentation within the eaves between dwellings, combined with the use of combustible materials for the soffit & fascia boards plus open roof vents which would not appear to have any intumescent protection. It certainly possible that the fire also spread at roof level across the vertical compartment line due to a lack of fire-stopping compartmentation between the non-combustible roof tile covering and the compartment wall (as per NHBC detail 7.2.16).
- 4.2.2 We would therefore conclude that the lack of continuity of vertical compartmentation at the eaves and within the roof covering contributed to the spread of fire from one dwelling to another, as a result does not comply with the functional requirement B4.

- b) Ensure all soffit vents are of an intumescent type which have been tested to BS476 Part 22 (1987).
 - c) Strip back roof coverings at the line of vertical compartmentation & provide fire stopping detailing at the eaves and roof pitch on the line of compartmentation as per the NHBC detail 7.2.16.

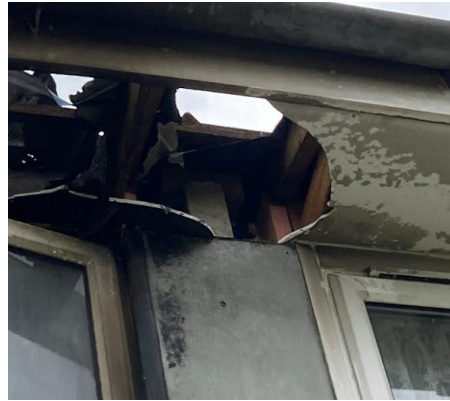
10.

4.1.2 Photo 10 shows the exposed eaves detail at the vertical compartment line to the front elevation between numbers 13 & 15, it is clear that no fire compartmentation detailing exists within the eaves, allowing an unrestricted route for fire to spread within the eaves from one dwelling to the next.

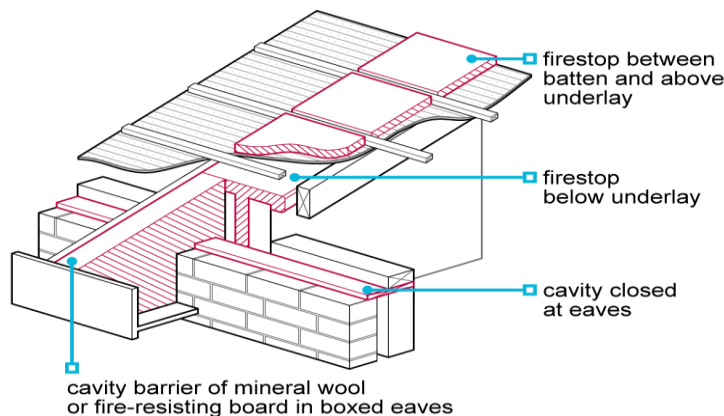
Figure 1 NHBC detail 7.2.16

4.1.3 Modern housebuilding detailing methods require the line of vertical compartmentation to be continued through the eaves and up the roof to the ridge to ensure the compartmentation between dwellings is continuous.
