## **ILLUSTRATIONS**

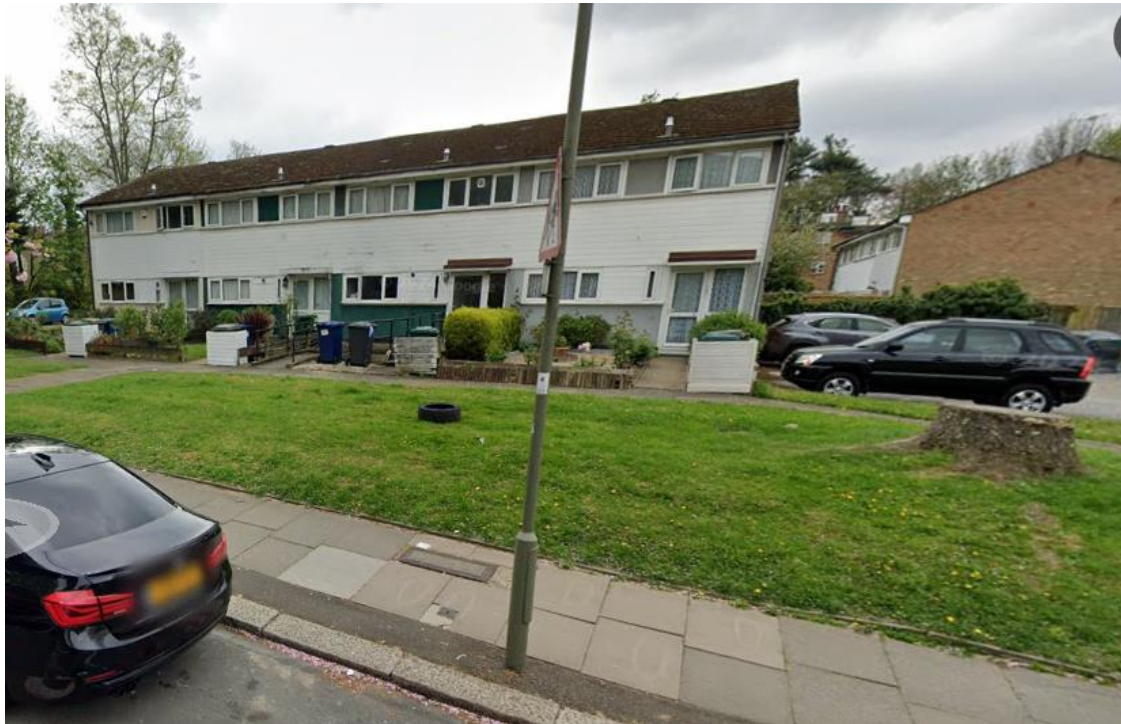
1. The front of the terrace. Number 9 is on the left: 15 is at the right. This image, taken in April 2022, was copied from Google Maps.

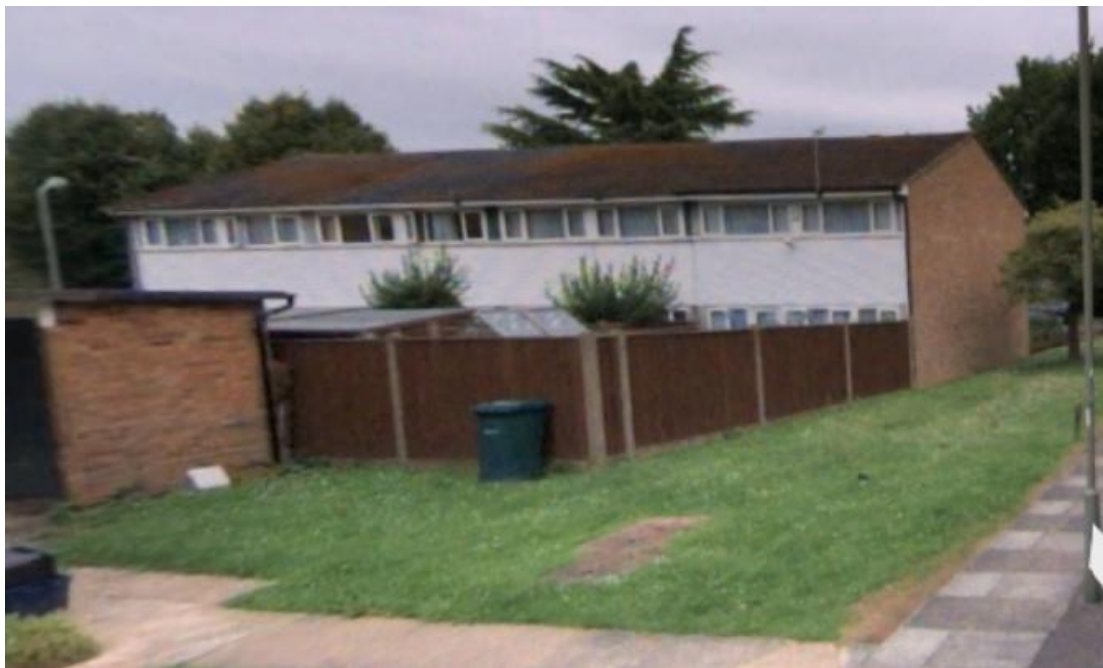
2. The rear of the terrace prior to the fire. This view, from a Microsoft Map file, was taken in July 2011. (The cedar tree visible on the other side of the terrace was subsequently felled.) No 15 is on the left: no 9 is on the right.

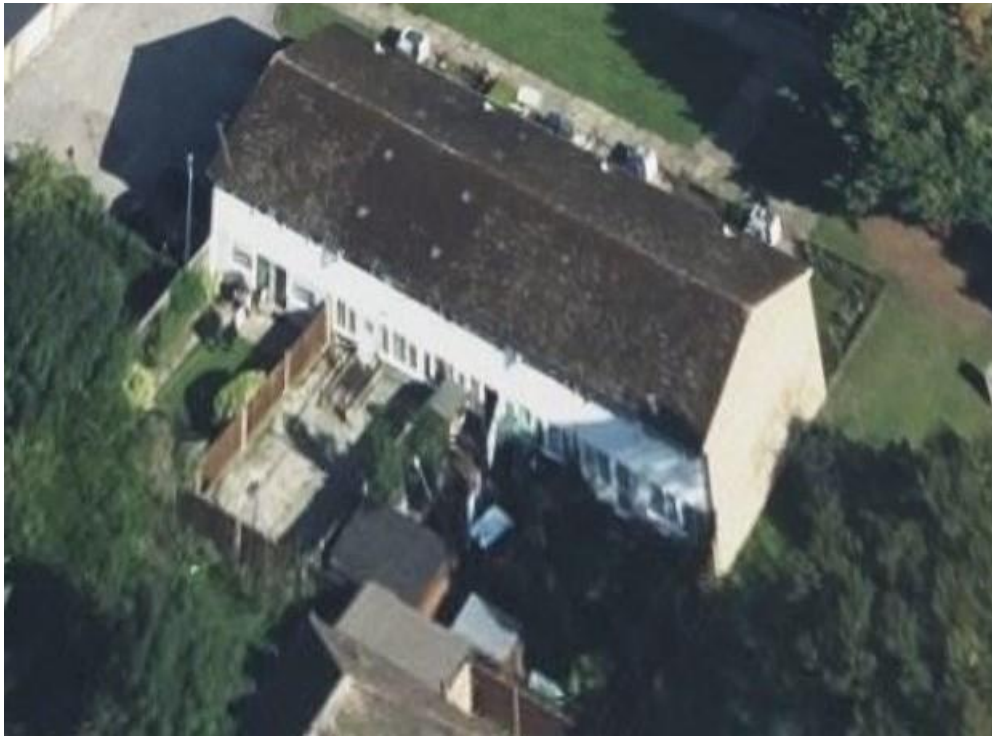
3. A Microsoft maps “birds-eye” view taken at unknown time before the fire. The back gardens of nos. 13 and 11 have been concreted over. That of no. 11 contains a large shed at its rear with two other structures and what appears to be a dividing screen nearer the house. The yard of no 13 is relatively empty. The timber fence separating this yard from the garden of 15 is clearly visible.

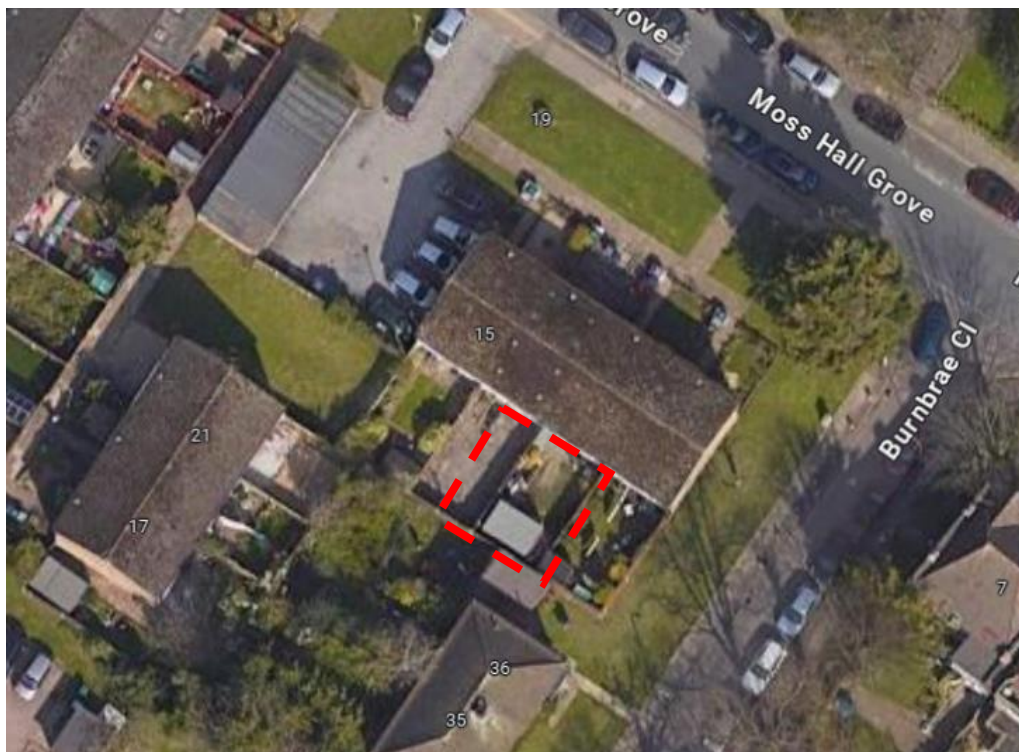
4. A Google “satellite” view taken a few years before the fire, with fewer items in the yard of no 11. The dashed red square shows the extent of the external fire. The rear yards and gardens are each about 5 metres wide by 8 m long. The external fire covered about 50 m<sup>2</sup> – more than the footprint of a house.

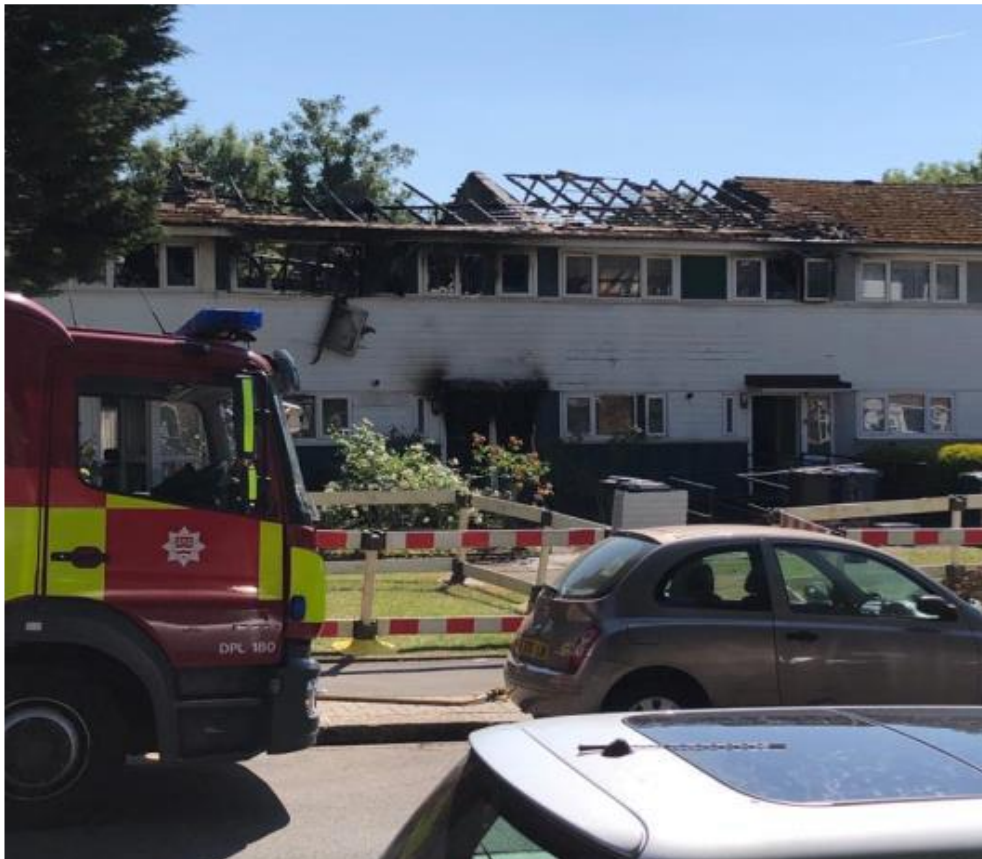
5. The front of the terrace. No 9 is on the left, mostly out of view. The house with the most severe damage is no 11, with 13 at centre right and 15 on the far right

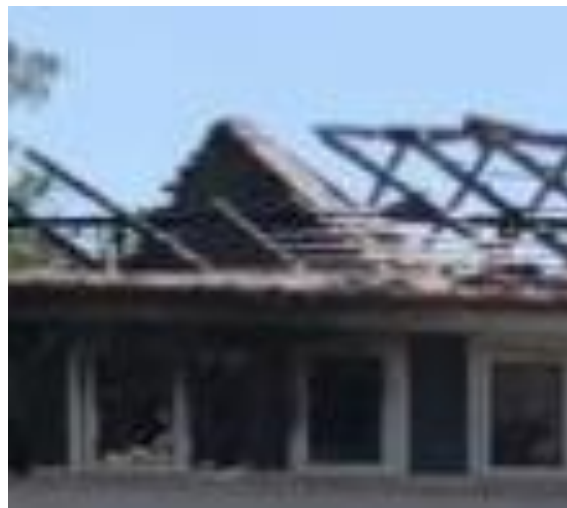
6. An enlargement of part of the previous photograph showing the party wall between no 11 and no 13. Most of the tiling battens have been destroyed by fire but some remain in place near the eaves. There should have been fire-stopping between the battens where they pass over the party wall: none is visible. It might have fallen away in the fire but I think it more likely that it was never present.

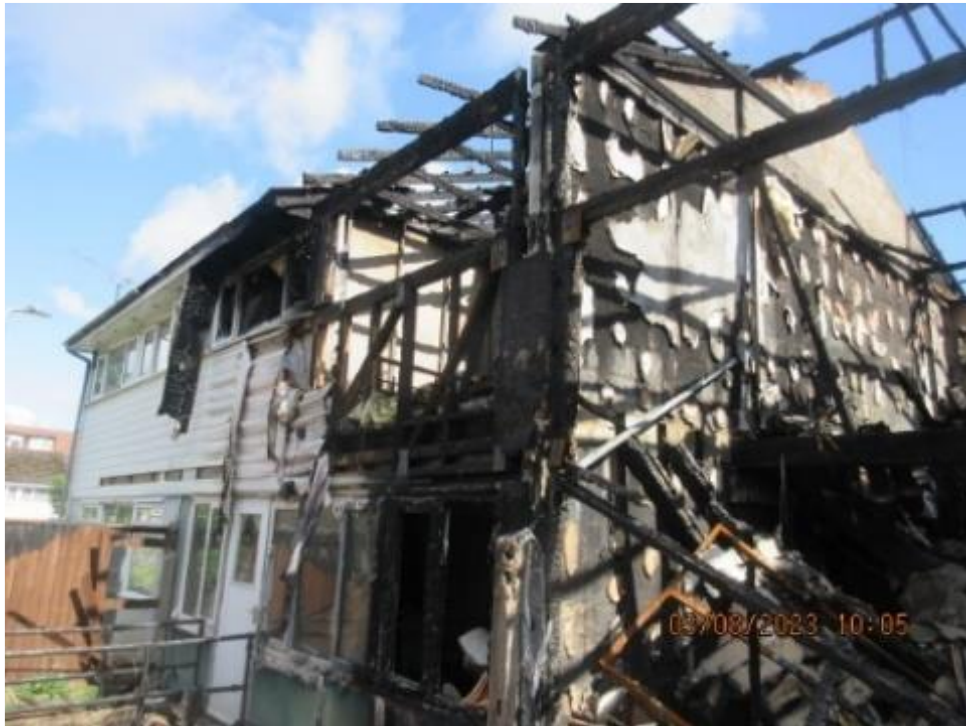
7. At the rear. A blackened section of uPVC eaves soffit is hanging down at the approximate position of the party wall between 15 and 13.

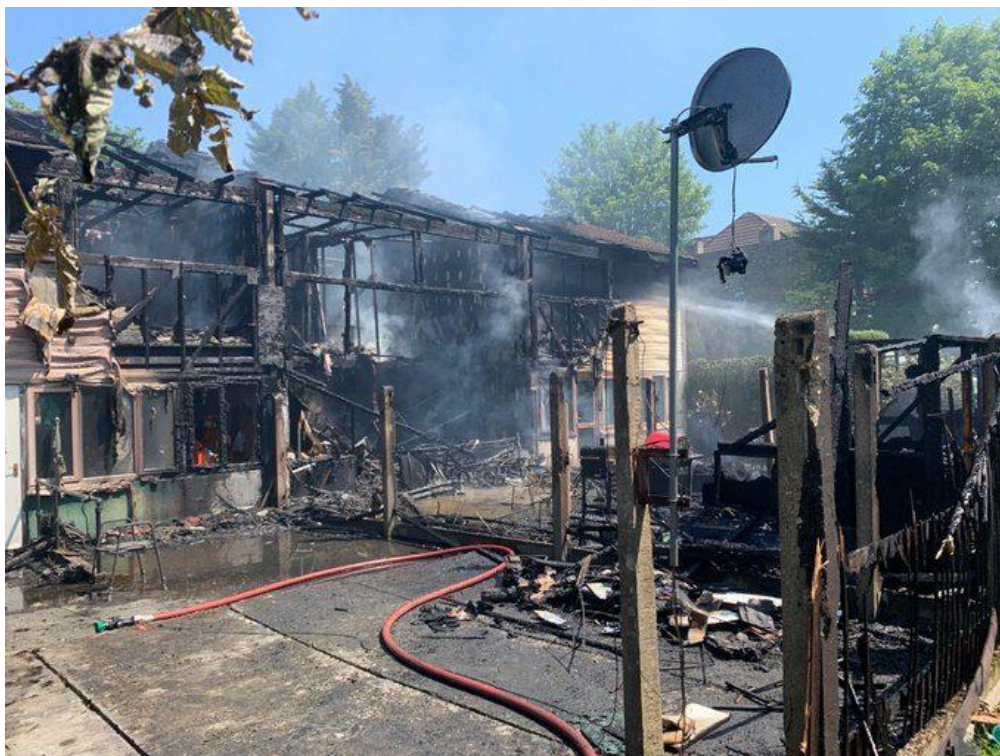
8. The yards at the rear of 13 and 11 seen from beyond the line of the rear fence. The pattern of damage to the uPVC cladding corresponds to what I would expect from flames from a severe fire burning close to the building and involving the whole width of the yard to no 11, plus the fences on either side. This flame impingement seems to have extended beyond the lines of the party walls to destroy areas of cladding on both no 13 and no 9. This photograph, copied from Parikiaki, was taken by the London Fire Brigade.

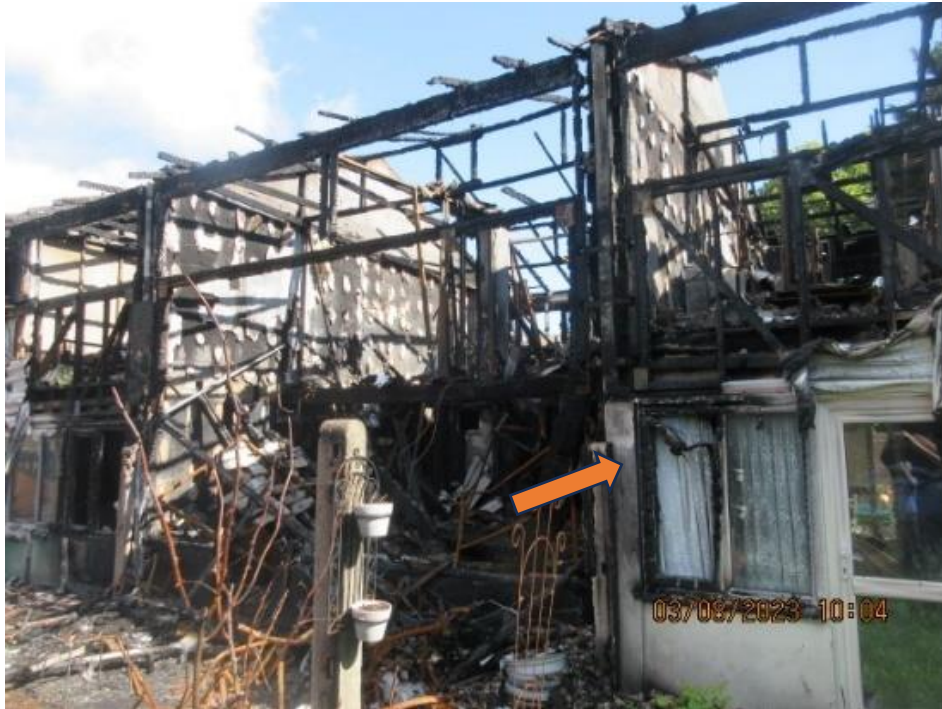
9. A view from the garden at the rear of no 9. The timber fence between the yard of 11 and the garden of 9 has been consumed by fire. The arrow indicates what appears to be a section of non-combustible board.

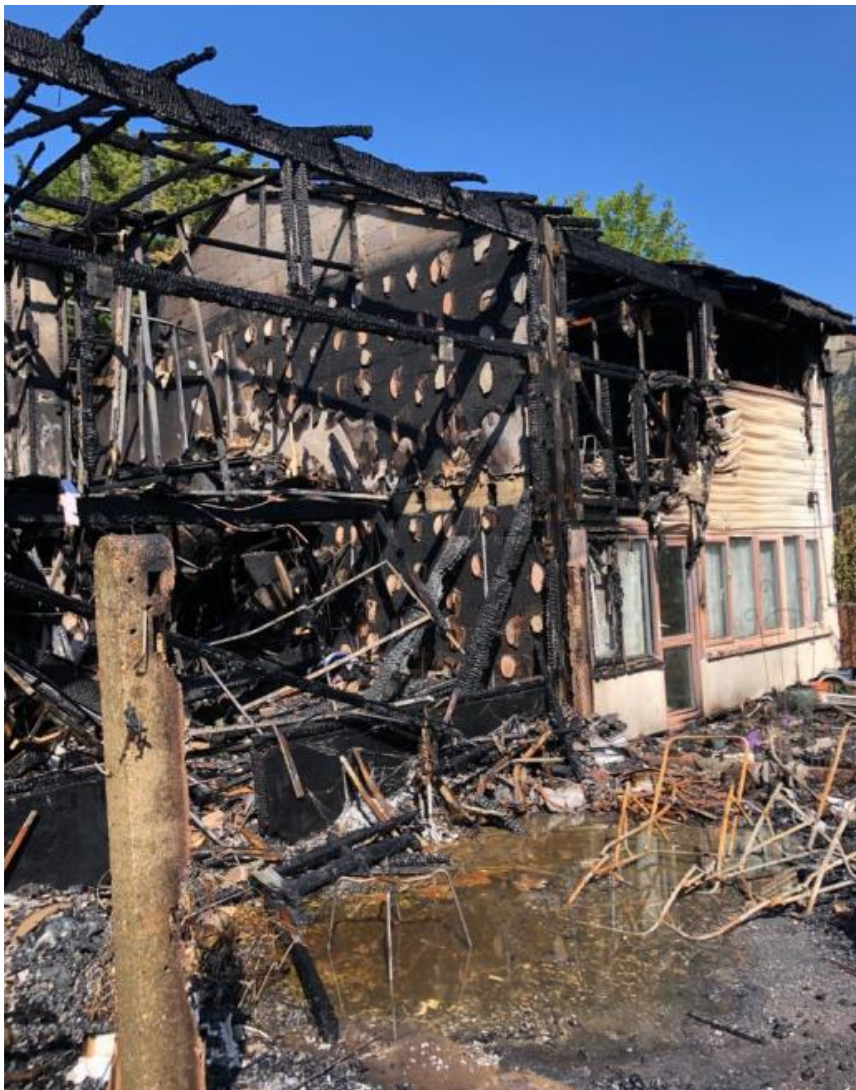
10. The yard at the rear of 11 contained many items, judging by the debris. The timber fences either side of the yard – one of which would have been directly in front of the camera – have been consumed by fire. The pinkish hue of the cladding on 9 is typical of heat damage.

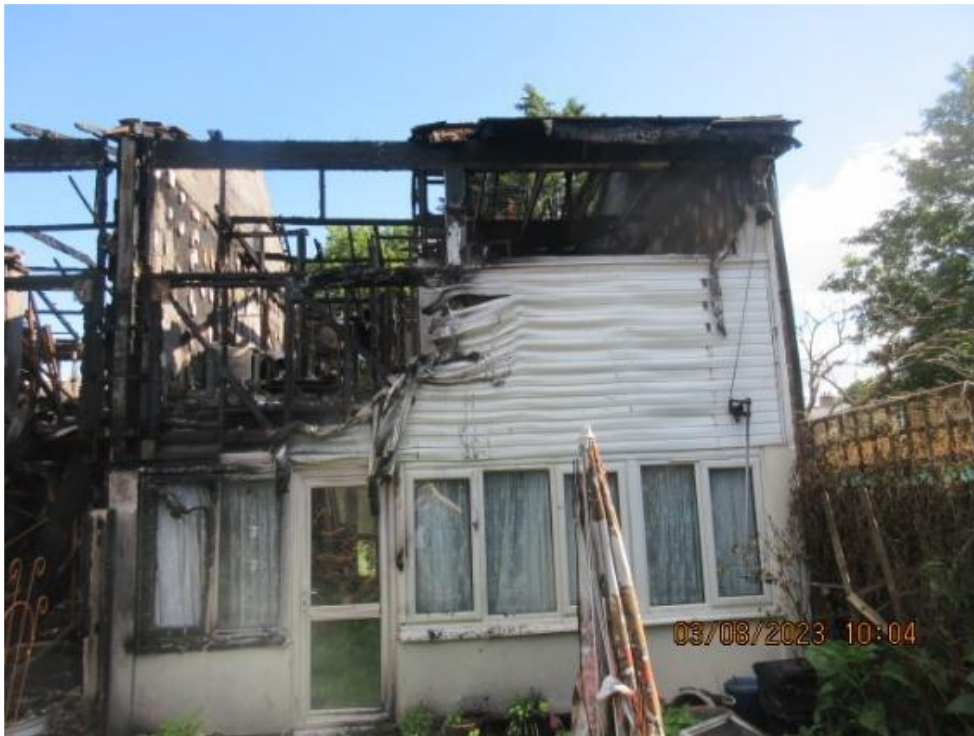
11. The rear of no 9. The destruction of the uPVC cladding seems to have been caused partly by direct flame impingement from the external fire involving the yard of 11 and the intervening fence, and partly as a result of fire inside the house burning through the plasterboard on the inside of the wall frames. The cladding remaining in place is damaged by heat but there has been no spread of flame across its surface.

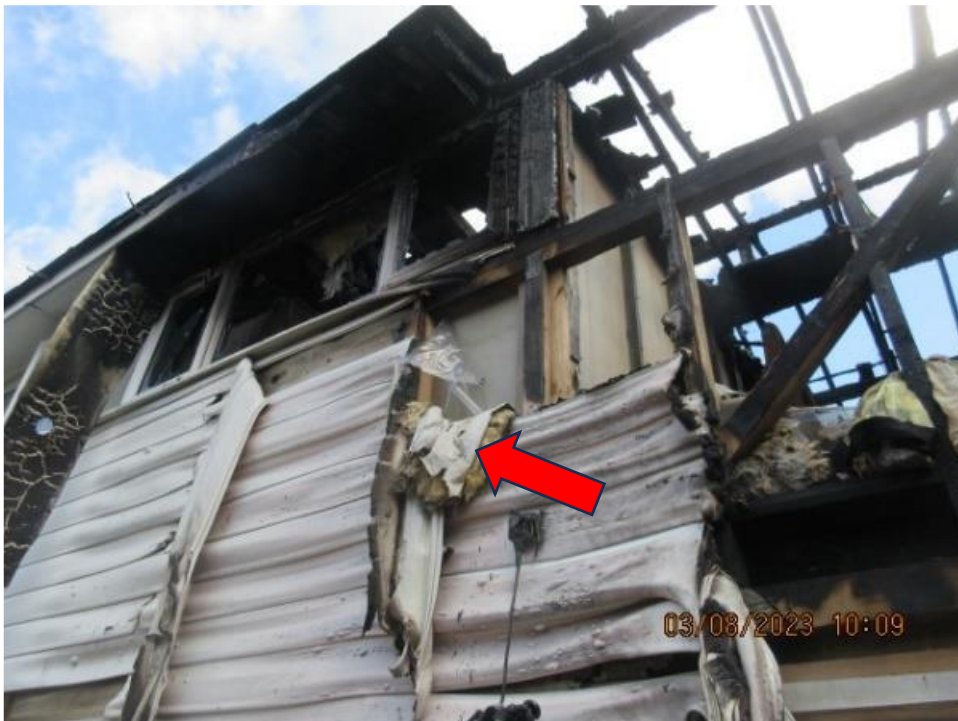
12. At the rear of 13. Some uPVC cladding had been softened by heat and had fallen away, exposing the wall frame behind. There is no underlying plywood at this point just mineral fibre (arrow) and the plasterboard inner lining. There has clearly been no spread of fire over the cladding here.

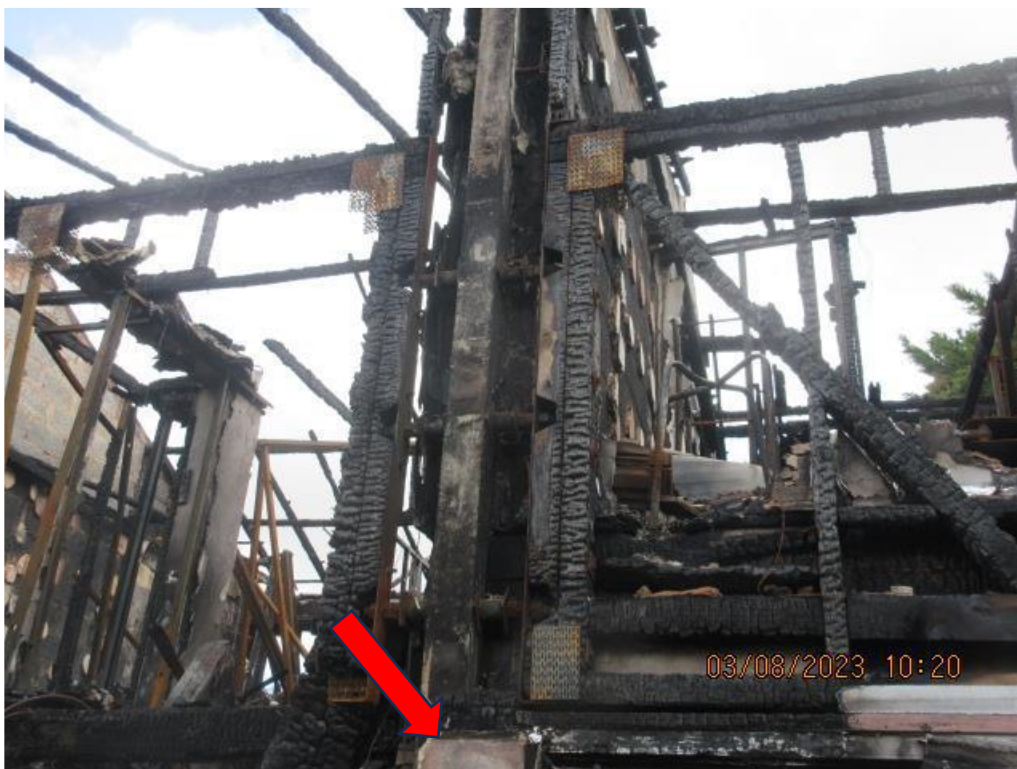
13. The party wall between 11 and 9. The wall frames of each house had been bolted to a concrete support post with the party wall built tight against the back of this post. The spaces between the post and the edges of the wall frames had presumably been packed with insulation and covered externally by some board material, now destroyed. A section of what appears to be a non-combustible board remains in position (arrow). This might have been a later repair given that it is only present on one side of the party line.

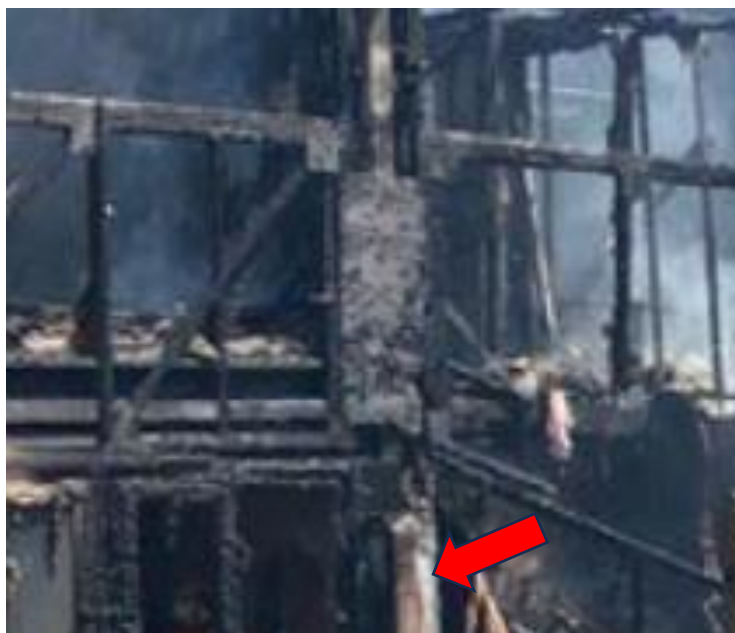
14. An enlargement of part of photograph 8 showing a charred area of board covering the concrete support post between 13 and 11. This could have been plywood. It would have been covered by the uPVC cladding. I doubt that there could have been a cavity allowing horizontal fire-spread behind the board and I also doubt that there would have been much of a gap between the board and the uPVC cladding. The arrow indicates what appears to be a section of non-combustible board half the width of the charred board.

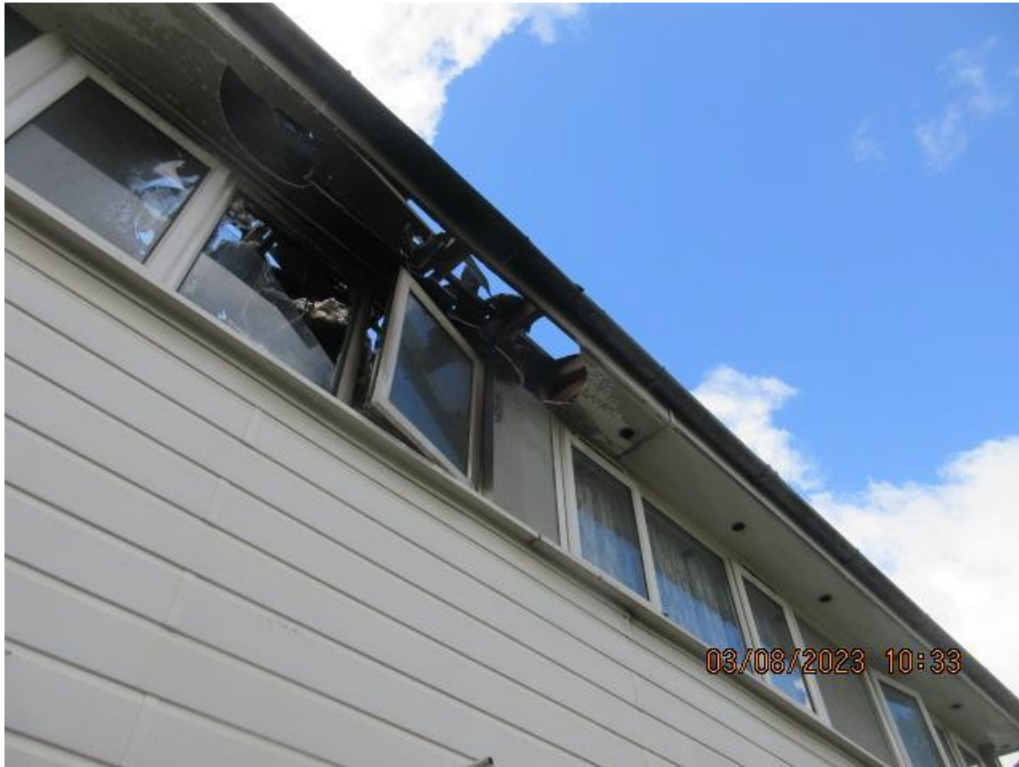
15. At the front showing the area spanning the party wall between 13 (on the left) and 15. The uPVC eaves soffit board of no 13 has been damaged but that of 15 is intact.

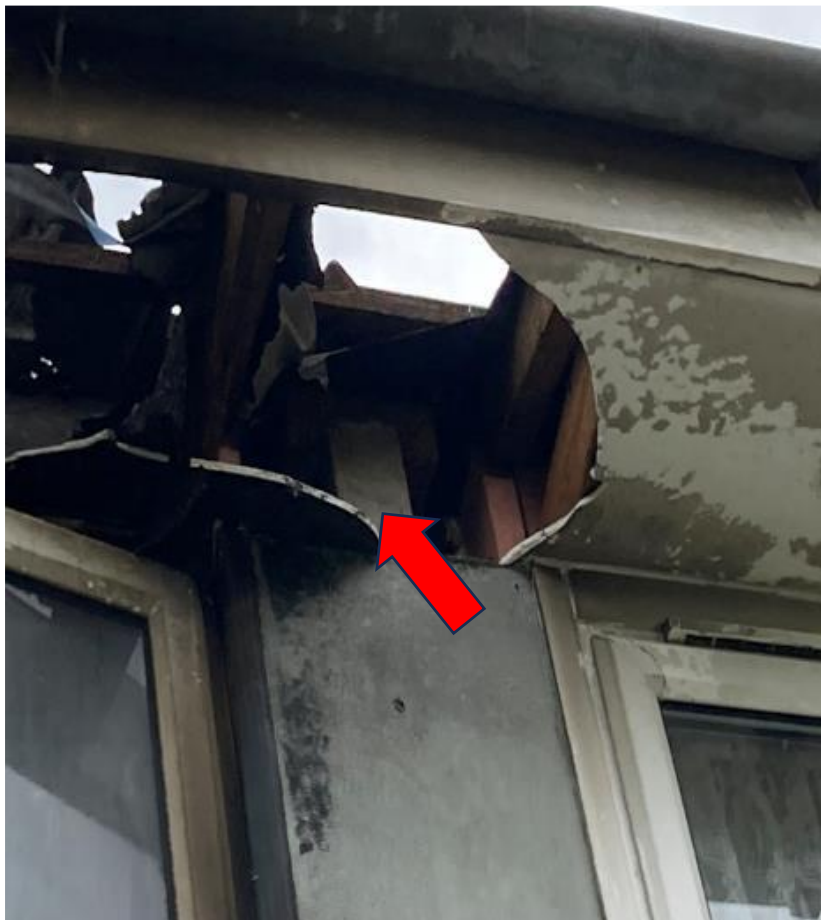
16. A closer view. The arrow indicates the top of the concrete post in line with the party wall. It is covered up to eaves level by board material. Part of the uPVC soffit has been torn away to reveal the lack of a cavity barrier to sub-divide the eaves void at the line of the party wall. Despite this short-coming, there has been no spread of fire through this part of the void, as can be seen by the lack of fire damage to the timbers visible to the right of the post.
