11-15 Moss Hall Grove, N12 8PE- Response to ██████████'s report

The purpose of his report is to try and compare the fire at Moss Hall Grove to possible risks at Watling Estate houses. This is a desktop case study comparing archetypes that are similar in so far as they both have timber frames. The age of the dwellings and external cladding are different.

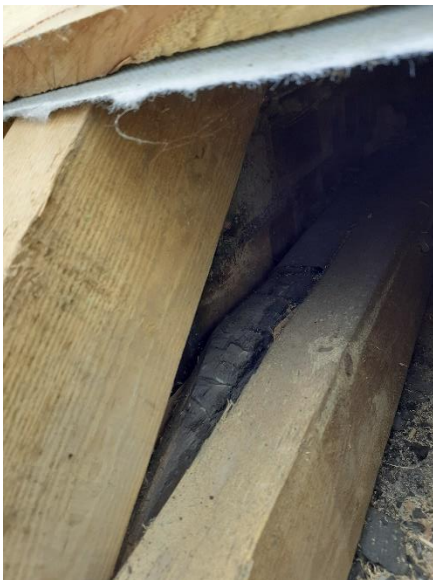
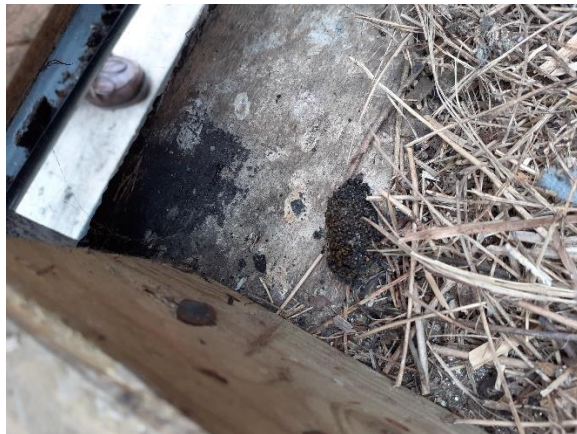
- 3.5 No additional comment necessary.
- 3.6 Clear evidence was noted of no cavity barrier at eaves level which is clear path for fire. This is confirmed by Capital and Mr [REDACTED] and is a relevant matter when judging deficiencies using the HHSRS.
- 3.7 The roof void was opened up between 38-40 Playfield Rd as part of the pilot detail project work. There is evidence of a historic fire that has partly spread across the party wall at roof level into the neighbouring house, indicating inadequate fire separation at roof beams level.

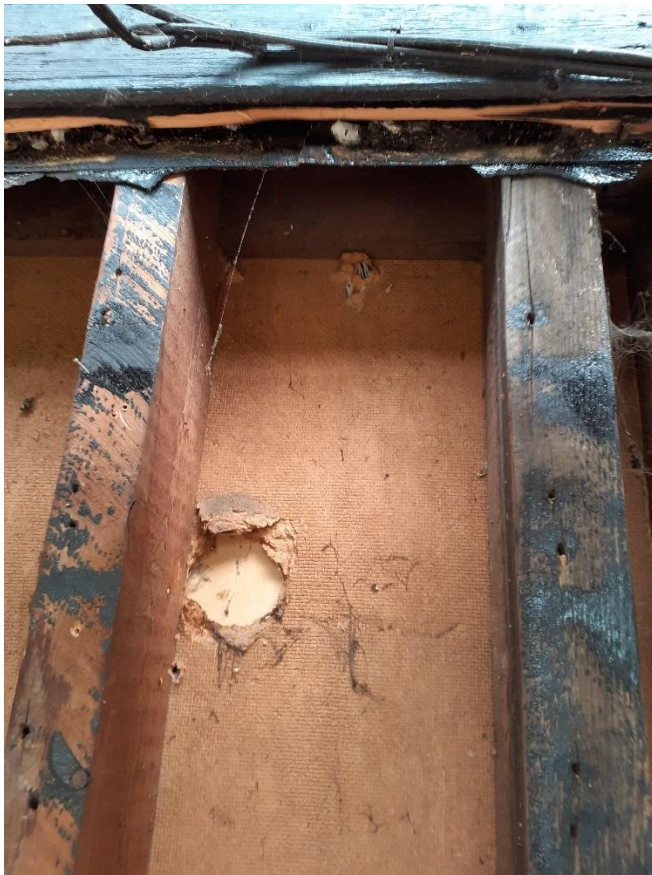
A pair of semi-detached houses in Watling Estate have been opened up extensively exposing the cavity. There was clear evidence that the internal plasterboard has been breached by occupiers hanging pictures and similar items to the walls with wall plugs (or similar fixings). An internal fire would find a hole into the cavity readily, the internal hardboard would ignite very rapidly and spread to the timber frame
