Response to Report of [REDACTED] in relation to the Fire at 9-15 Moss Hall Grove 08th June 2023

1. Introduction

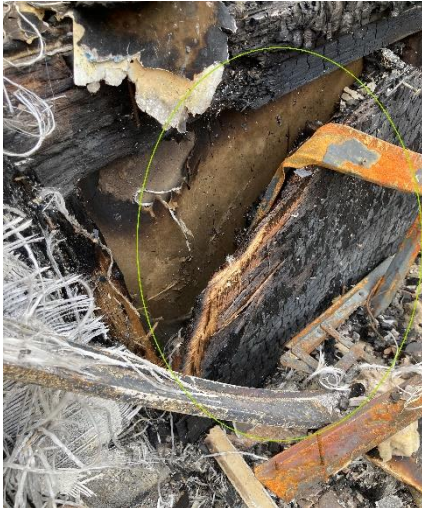
2.9 – Charred outer plywood cladding to the lower wall highlighted, showing evidence of surface spread of flame

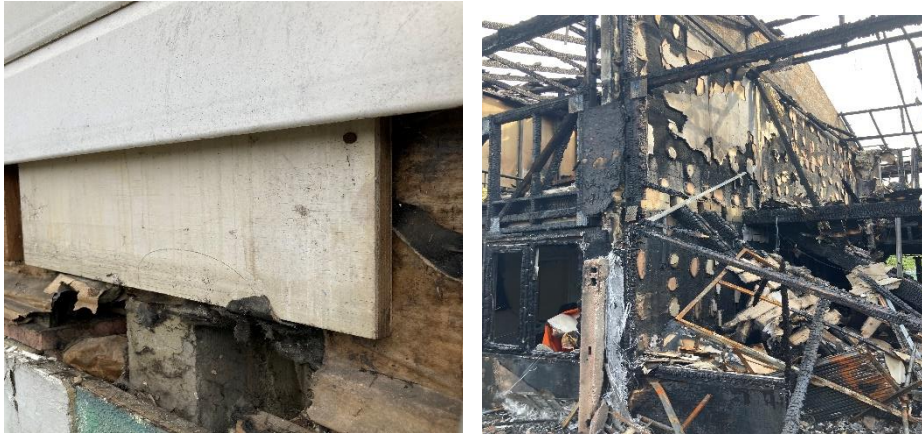
2.16 & 2.17

Photographs clearly showing combustible plywood cladding to the lower floor, plywood sheet & UPVC cladding spanning the party wall line to the upper floor, no insulation is present, also fire damage to remains of the plywood sheeting indicating surface fire spread via this route. Inspections into these areas were carried out.

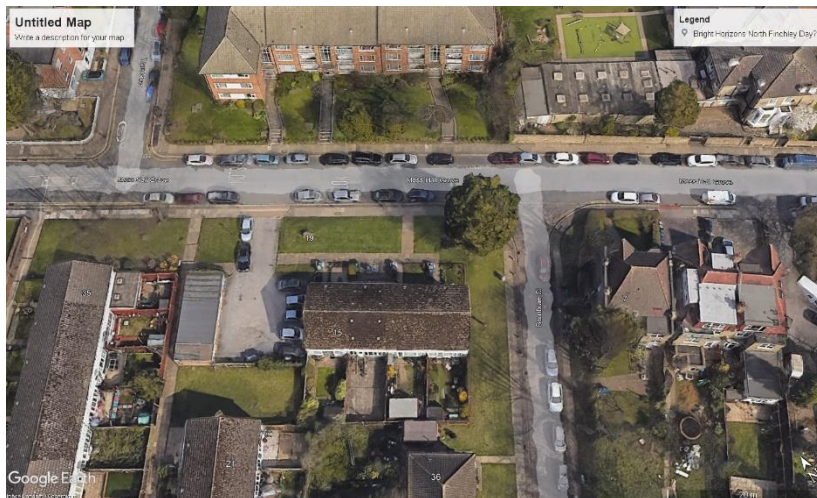
2.18

Aerial image showing rear of 11, there is a modest (approx. 3.5 x 2.5m) shed at the bottom of the garden, furthest from the house (approx 5.5m), contents unknown. I do not agree with Mr [REDACTED] conjecture that a fire which originated in & consumed the shed was the cause of such extensive damage to the houses, rather it is a more likely scenario that it was the houses which ignited and the radiant heat generated from the intensity of the large fire caused the shed, fences and other garden elements to combust and be consumed by the rapidly spreading fire.

3.1 – There is no evidence of the fire of a high fuel load in the yard behind No. 11, save the modest shed at some 5.5m from the rear of the house. As a result, no evidence to support Mr [REDACTED] theory. Initial reports from Barnet Homes were that the fire originated from a motor bike leaning against the back wall of the house
