Fire Spread Investigation Report

**9-15 Moss Hall Grove
London
N12 8PE**

For
Barnet Homes
2 Bristol Avenue
London
NW9 4EW

11th July 2023

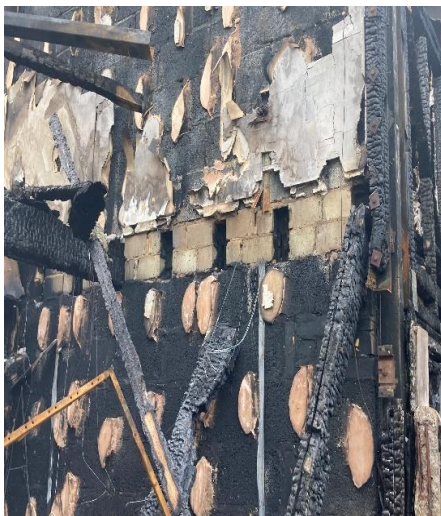
4.

2.1.2 The houses are of timber frame construction, with 260mm masonry compartment party walls separating the individual dwellings, with cavity masonry flank walls at each end of the terrace. The first floors of the houses are of timber joist construction which is in-built into the separating party walls at either end (photo 4). The front and rear walls are constructed of a timber framed arrangement which are tied to the party walls via a concrete post with mechanical fixings (photo 5). The roofs are timber truss framed, pitched roofs with a concrete tile covering.
