9- 15 Moss Hall Road, London N12 8PE

Type 3 –1970's UPVC/timber sheet cladding

1.0 HHSRS assessment

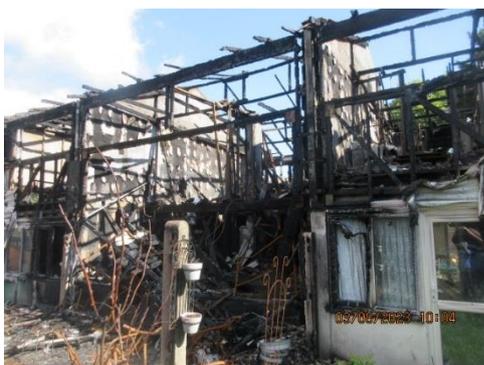
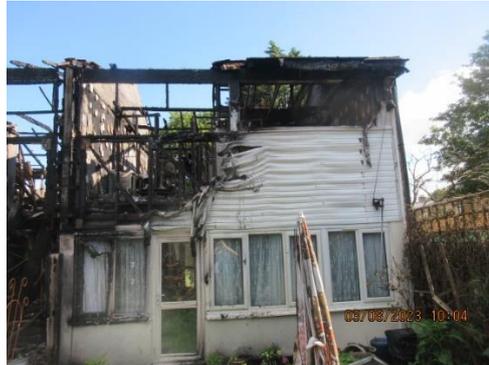
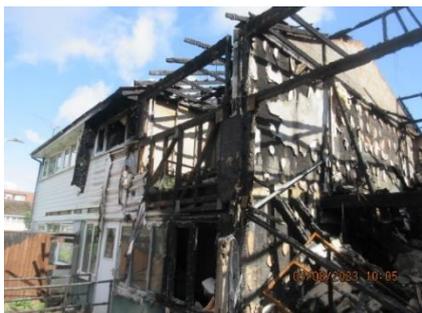
3.3 It is understood that the fire originated and took hold at the rear of the terrace and rapidly spread to the adjacent buildings either side, resulting in severe damage to all 3 of the mainly affected properties, the end house having significant internal damage.

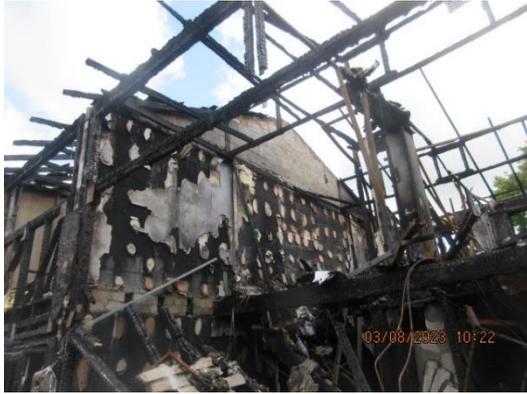
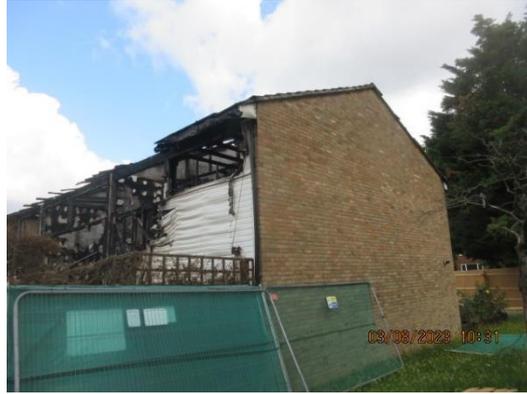
5.5 The first floors of the houses are of timber joist construction which is in-built into the separating party walls at either end. The front and rear walls are constructed of a timber framed arrangement which are tied to the party walls via a concrete post with mechanical fixings. The roofs are timber truss framed, pitched roofs with a concrete tile covering.

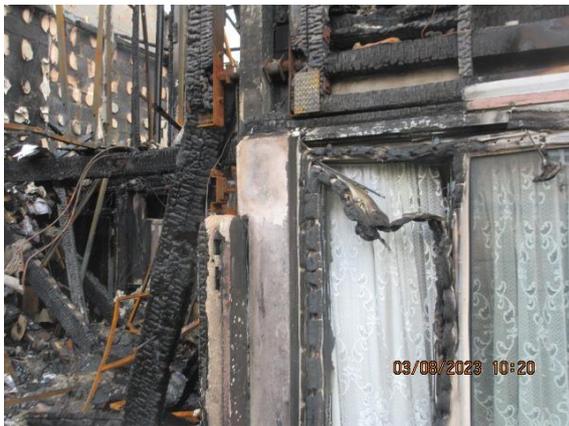
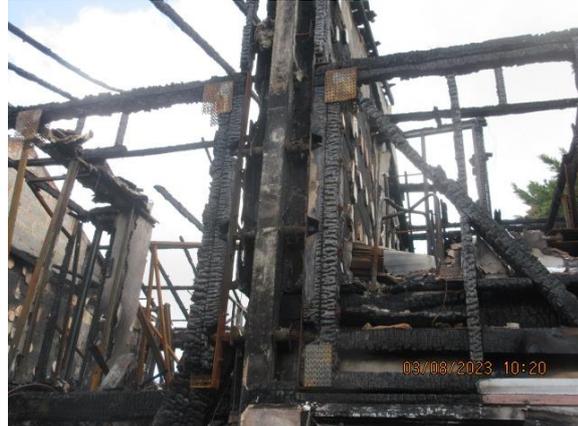
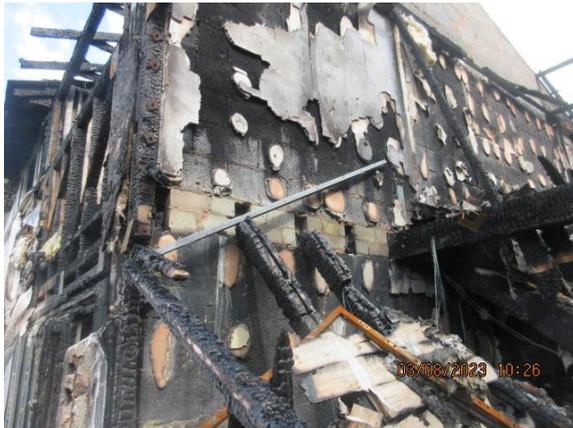
5.6 The front and rear external wall finish are UPVC cladding panels over plywood sheeting that have been attached directly to the original timber frame. It appears very likely that that the panels were attached in long sections with no fire breaks between the houses across the façade.

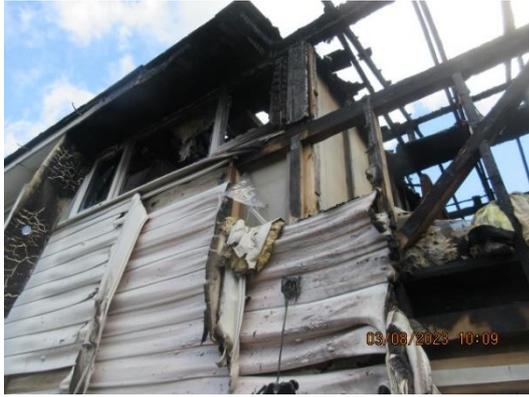
Rear view number 13

- 5.7 The UPVC cladding clearly bridges the fire compartment, exposing the plywood sheathing leading to the rapid spread of flames across the external wall. Parts of the front of the terrace appear not to have been correctly insulated. The plywood sheathing is clearly visible.

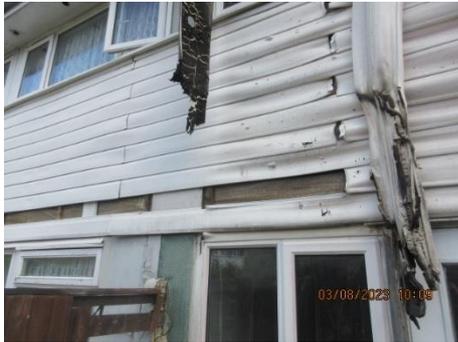
Rear view 11 and 13

- 5.8 The roof eaves soffit and fascia boards are similar UPVC. It is likely that these are replacement elements. The soffit boards are vented at regular intervals to provide ventilation into the roof space. There is no fire compartmentation at the roof level. There was nothing to stop the rapid spread of flames along the soffit and into the roof space.

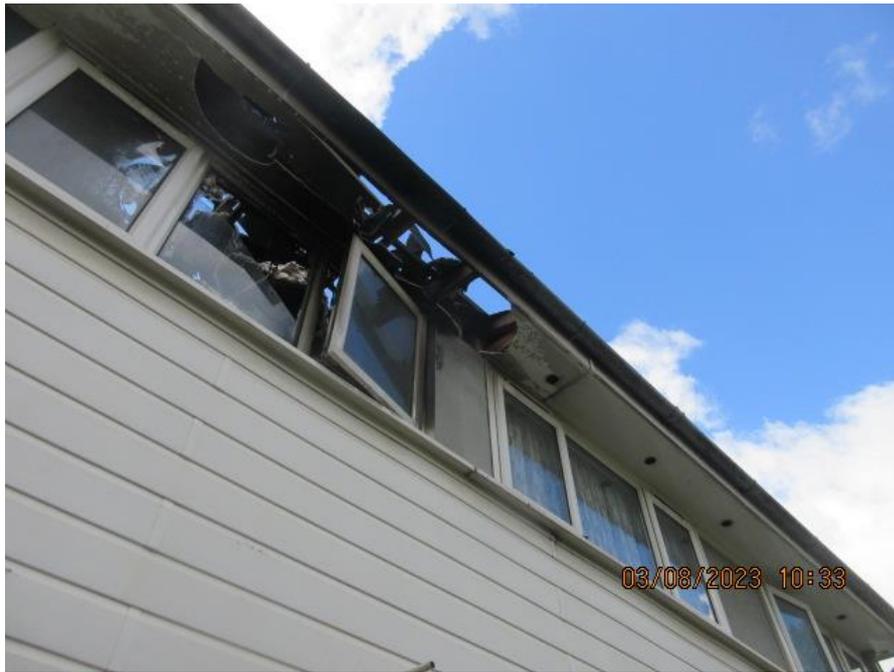
5.9 The combustible UPVC & timber sheet cladding fixed directly to the timber battens, allowed for the spread of the fire from one house to another as there were no barriers to stop the spread between the timber frame.
